Basic Sanitation Analysis of Austin Resto Restaurant in Medan City

This research is a descriptive study with an observational design, describing the sanitation of the Austin Resto restaurant in Medan. In this study, the object of observation is the condition of Basic Sanitation at the Austin Resto restaurant in Medan.

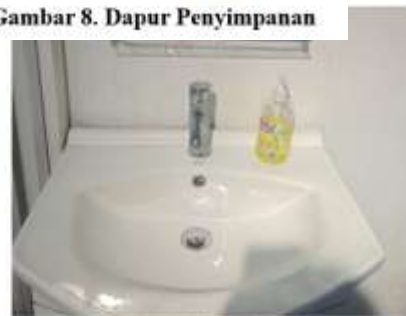
Gambar 5. Washtafel

The hand washing area is not used because the tap is broken so food handlers wash their hands using water from the sink, there is only 1 toilet available and it is not clean.

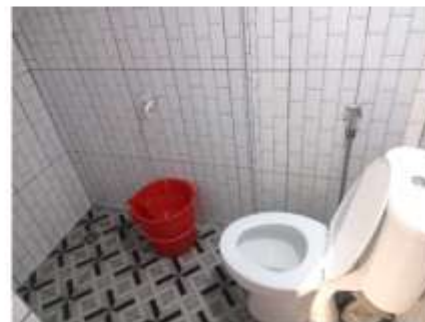
Gambar 6. Toilet

The toilets are not directly connected to the kitchen or dining room. They are not separated for men and women, and are clean, with soap and a hairdryer or cloths available.

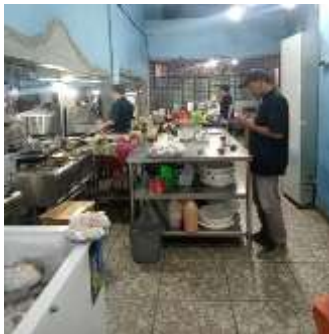
Figure 12. Food equipment washing waste

Wastewater drains smoothly and is watertight, but not sealed, which gives off an unpleasant odor. Observations indicate that wastewater is disposed of through drains, sewers, or ditches. This demonstrates compliance with Ministry of Health Regulation No. 1096 of 2011 concerning Health Hygiene and Sanitation.

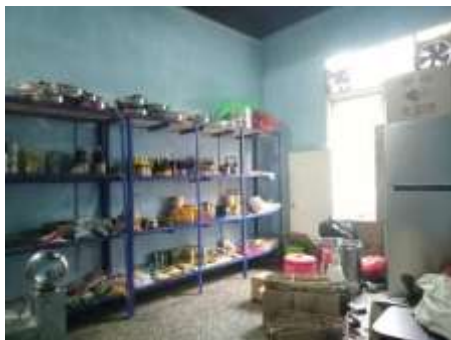
Figure 16 Kitchen Ceiling

Permanent open ventilation, the floor in the kitchen is waterproof but watery and oily which can result in work accidents, if the floor is not conical it is difficult to clean and can also be a place for the development of microbial pathogens which will later contaminate cooking utensils and food ingredients and so on. This shows that the condition of the sanitation facilities of the AUSTIN RESTO restaurant has met health requirements with a percentage of 66.92%.

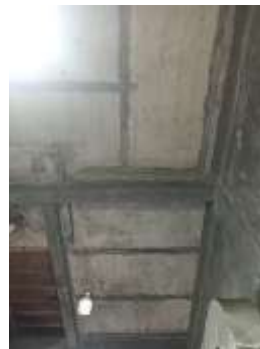
Figure 17 Pantry Kitchen

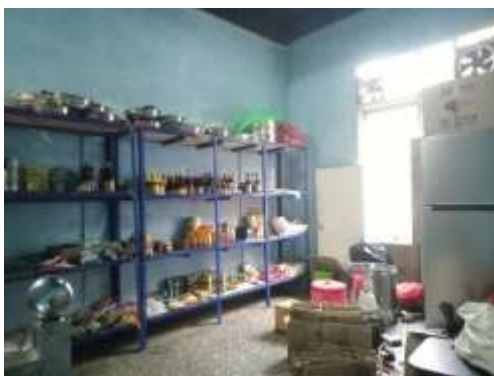
Figure 18 Food Warehouse

The results of the research conducted at the Austin Resto Restaurant showed that the food ingredient warehouse with a percentage of 79% of the category meets the requirements at the Austin Resto Restaurant. There are two warehouses, one for rice, one for food ingredients. The warehouse does not meet the requirements because the warehouse is narrow, the food ingredients are messy.

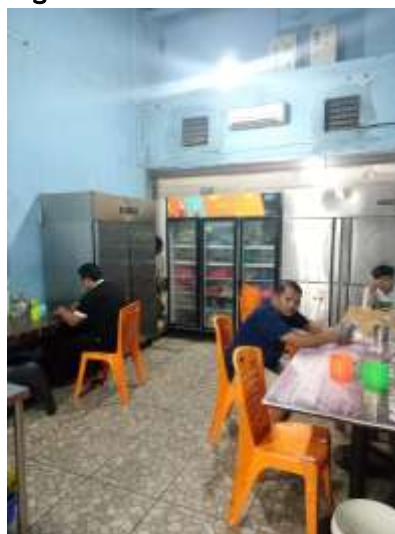
Figure 19 Storage of Cold Food
Ingredients

Food storage is placing food according to its type with rules according to the food storage location, food storage temperature and storage duration. The concept used in food storage is a way of organizing, storing, maintaining, and securing dry and wet materials, both in terms of quality and quantity in dry or wet food warehouses, as well as recording and reporting. Dry food materials are stored in warehouses and on hanging shelves, while wet food materials are brought directly to the preparation area and stored in the refrigerator. This activity is carried out by employees, based on the results of research conducted by the Austin Resto restaurant that storage and arrangement get a percentage of 80% with a qualified category.

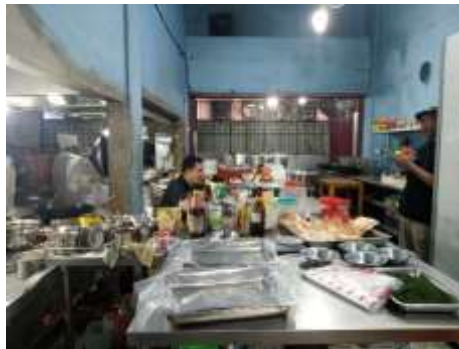
Figure 20 Food Processing

Based on the results of food processing researchers at the Autin Resto restaurant, food processing gets 70%, Food processing is done every day and the portions are adjusted to the number of customers and the menu is adjusted to what is ordered. Using tools when taking food, all food handlers have met health requirements, so that food will be protected from contamination through the hands of the handlers. Hands must always be kept clean, namely cutting nails, skin must be clean, cleaning hands with soap, free from cosmetics according to research, food handlers do not maintain long nails according to what is indicated in the sanitation guidelines for food hygiene and sanitation.

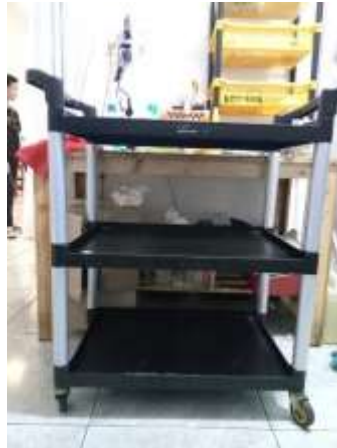
Figure 21 Food Transportation

Food transportation with a presentation of 100% of the means of transporting finished food from the storage area to be served, food serving is serving finished or cooked food to consumers using containers, in the food distribution process, employees carry out portioning by filling the food containers of the customers, After everything is served neatly, food handlers use closed trays to avoid existing contamination to transport finished food to each room at the time specified by the order.

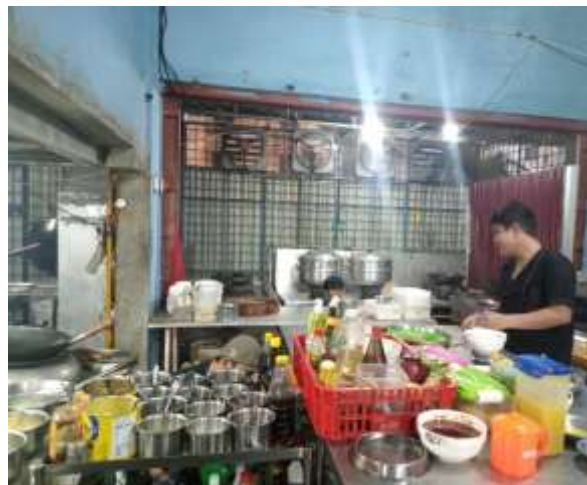
Figure 23. Food Equipment

The equipment used to serve and eat food does not meet the requirements with a percentage of 60%. The results of this study indicate that many consumer containers that will be distributed to consumers do not have container lids, but the person in charge of managing food at the Austin Resto Restaurant in Medan City has a policy of closing uncovered containers by overlapping one container with another, as far as research and interviews show that consumers are responsible for their own food containers, but there are some who are found to be less concerned about the cleanliness of the container, so employees will wash it again.
